THE ARGO MERCHANT OIL SPILL ON-SCENE COORDINATOR'S REPORT

United States Coast Guard
Marine Safety Office
Boston, Massachusetts

December 1977

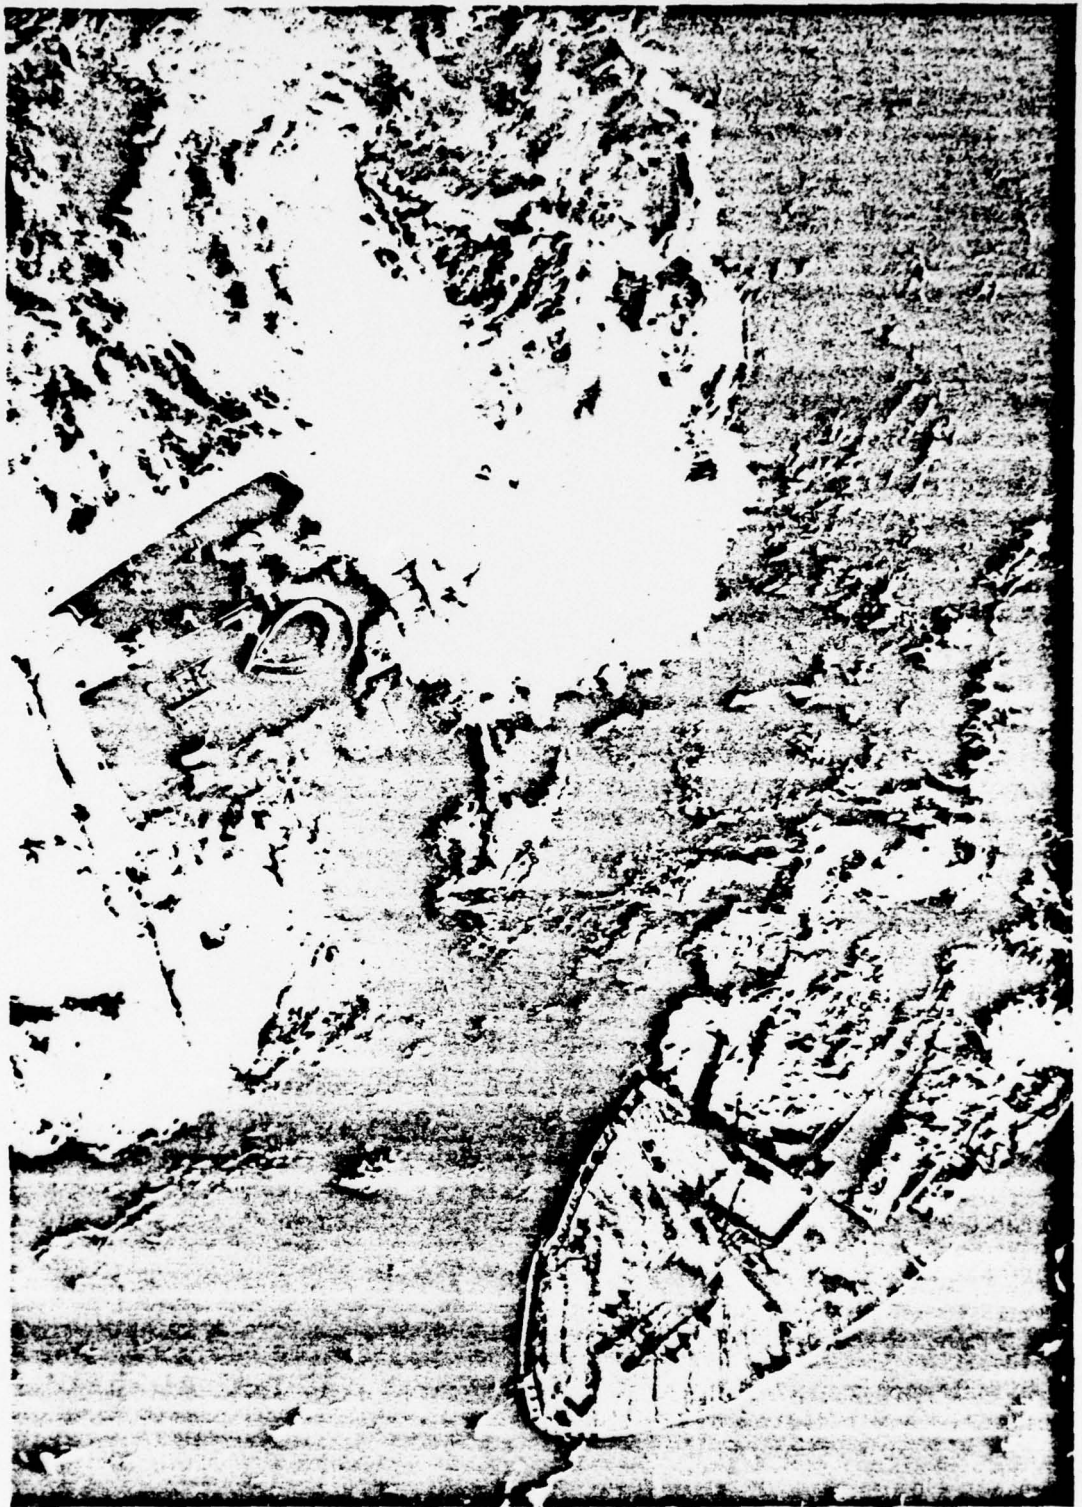
FRONTISPIECE — ARGO MERCHANT BEING BATTERED BY SEAS ON
FISHING RIP SHOAL, NANTUCKET, 22 DECEMBER 1976
(EPA Photo)

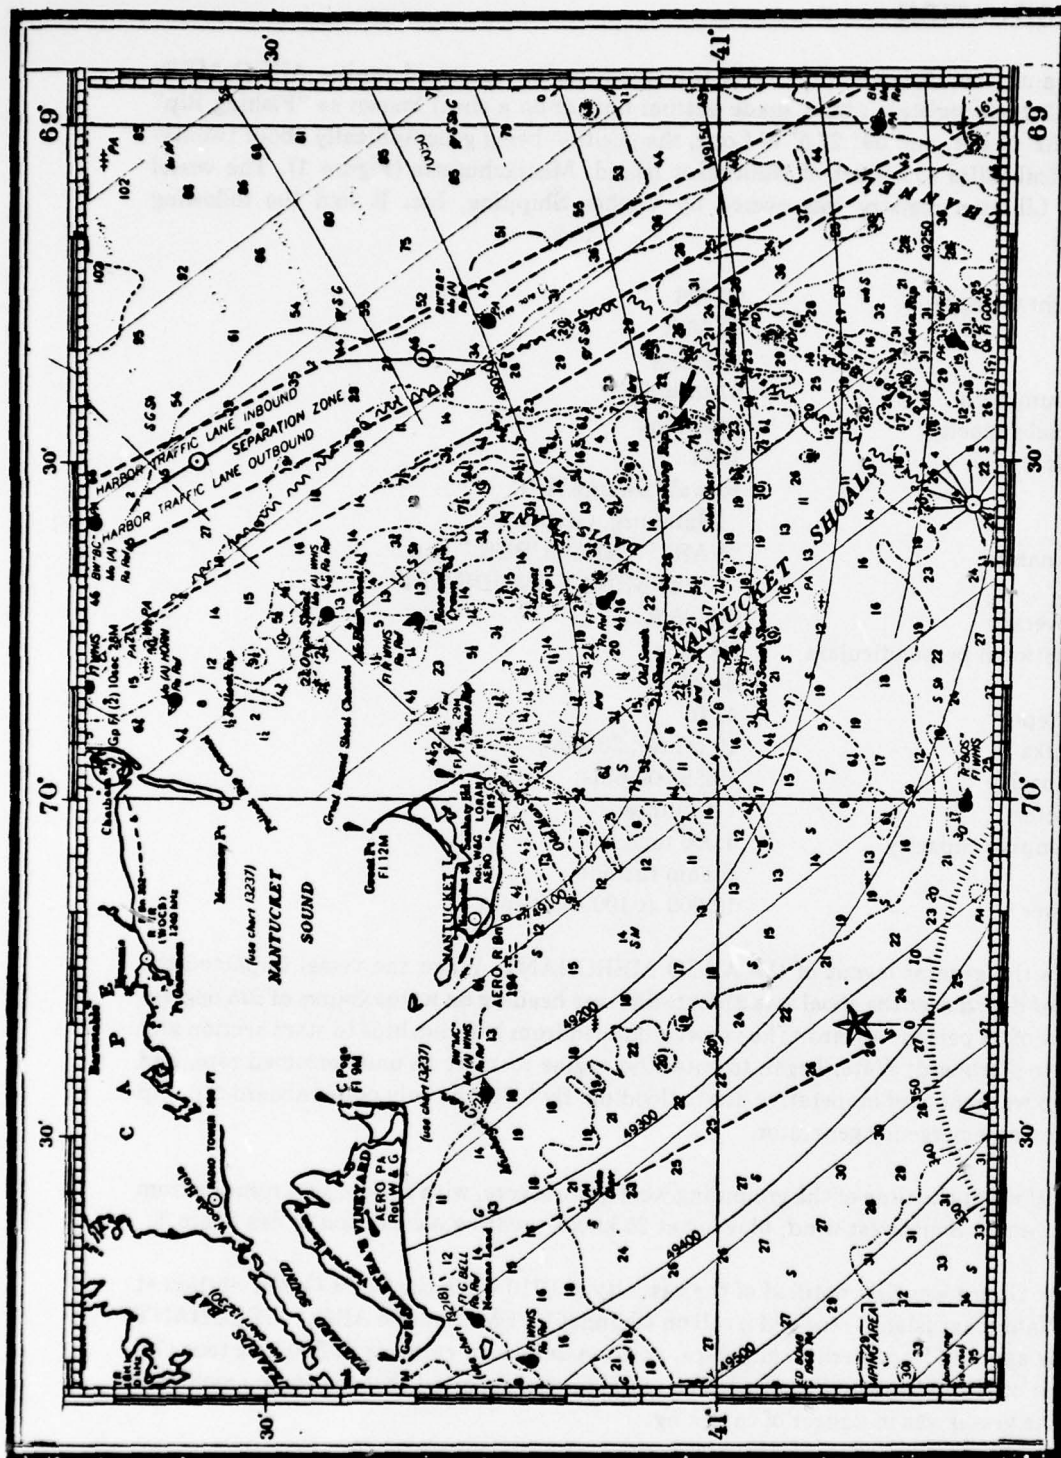
FIGURE 1 GROUNDING SITE OF ARGO MERCHANT

When the vessel grounded on Fishing Rip shoal, it was 12 nautical miles inboard of the normal traffic lane. As a result the vessel entered charted shoal waters having a mean low water depth of 21 feet (Figure 1). At the time of the bottom impact, the ship had an undetermined draft at the stern. With the engine and pump rooms flooded after grounding, the vessel's draft was observed to be 36 feet aft and 34 feet forward.

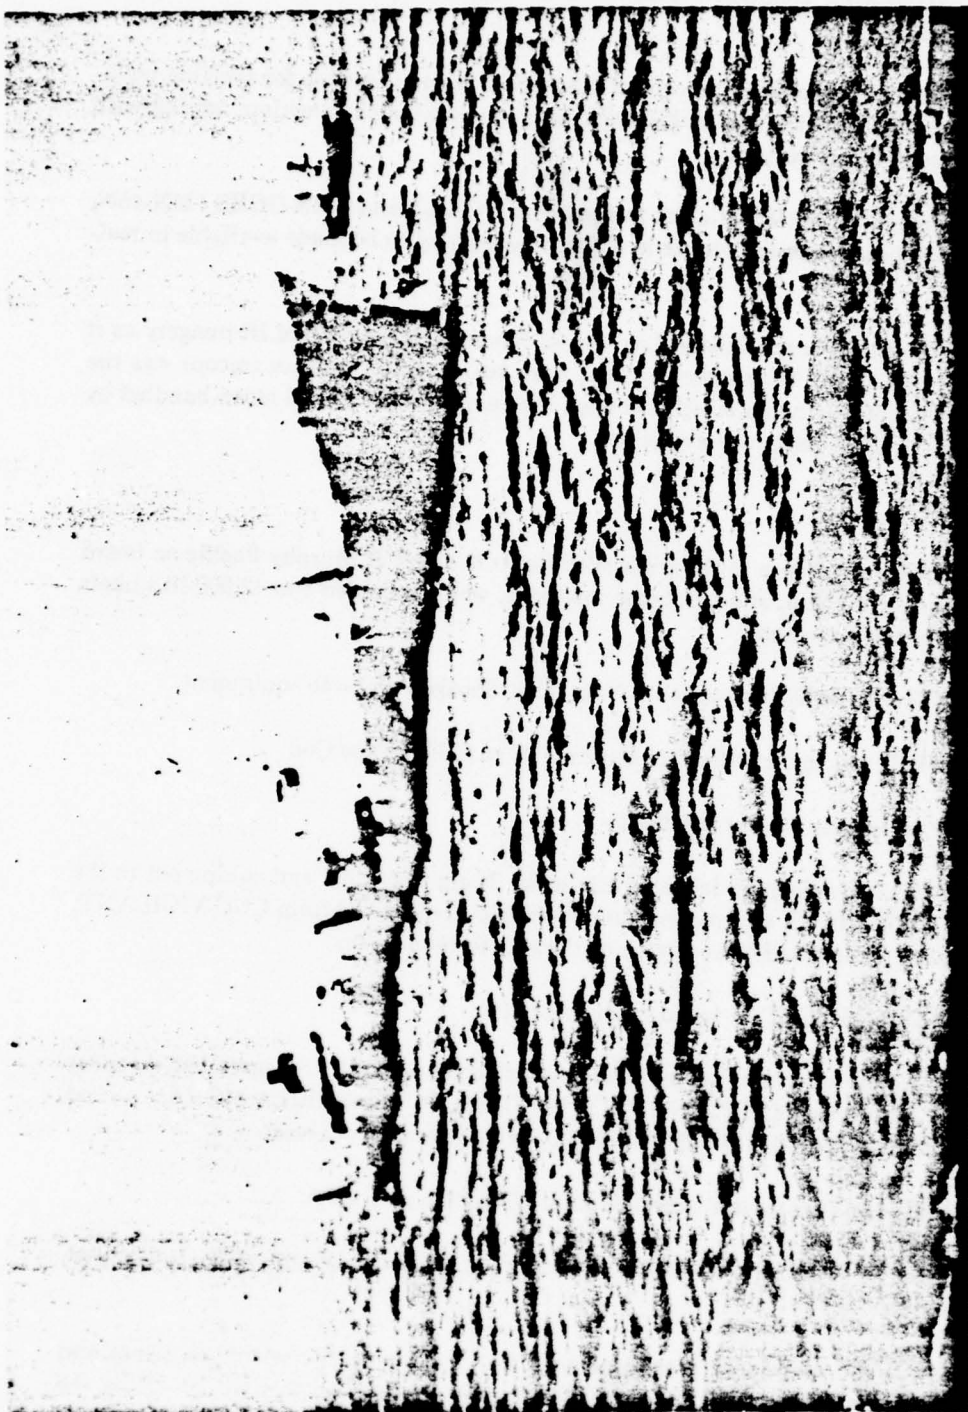
FIGURE 7 ARGO MERCHANT ON 20 DECEMBER 1976

- 1037
- CGC BITTERSWEET on-scene to set moorings.
- 1113
- Vessel condition remained as before, vessel aground with 15-degree list, heading 239°T at position 41°02.2 N, 67°27.5 W (Figure 7). Tug SHEILA MORAN placed port anchor of ARGO MERCHANT 030° relative to bow of vessel.

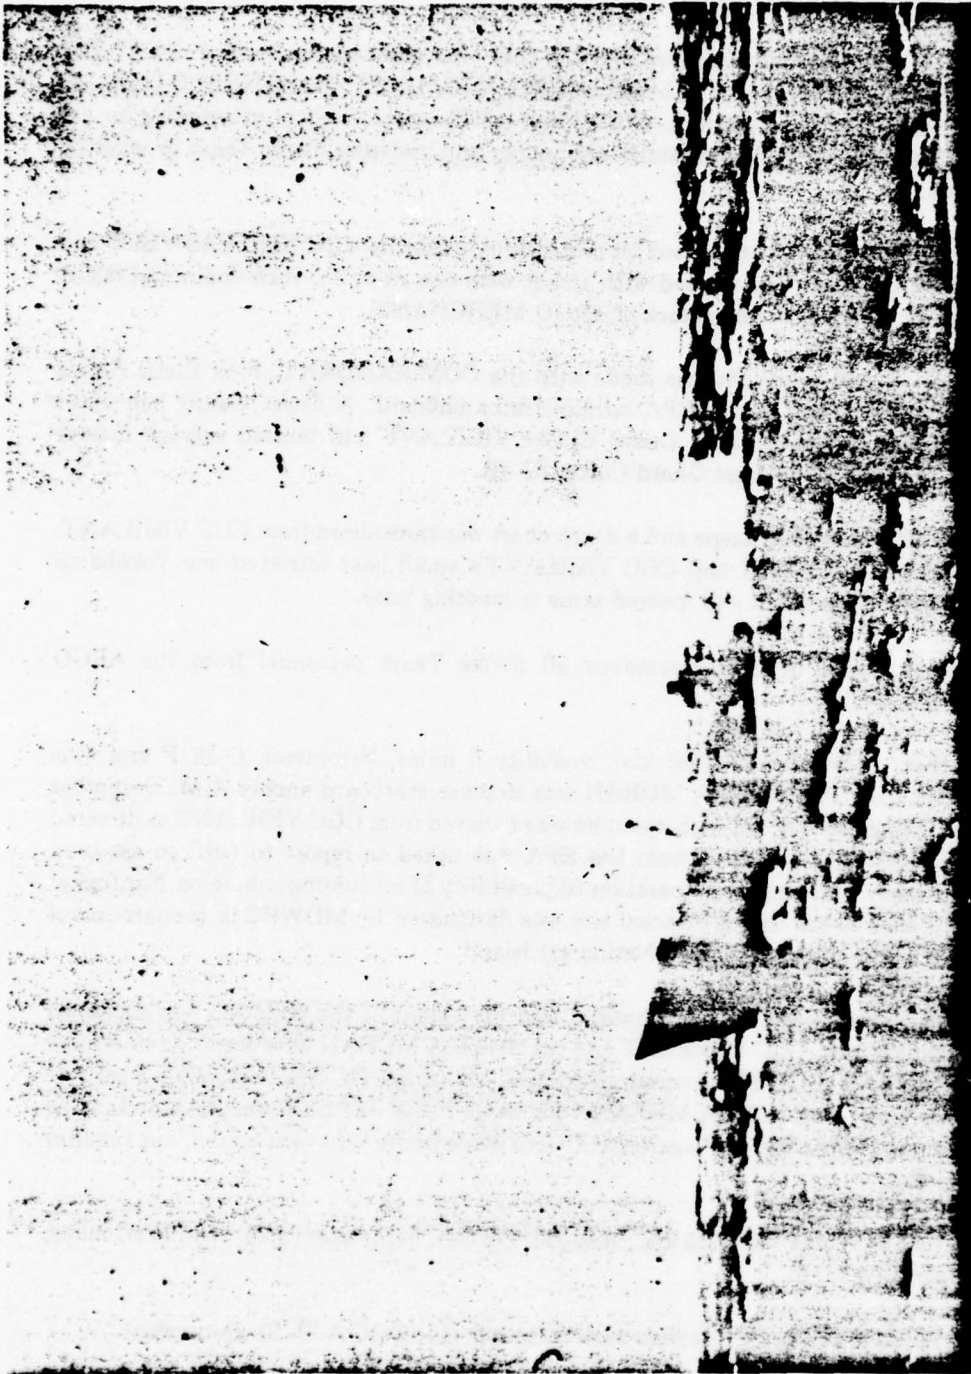
FIGURE 8 ARGO MERCHANT ON 20 DECEMBER 1976

- Bow of ship pitching occasionally up to 10 feet. Present heading 258°T, stern section had sunk 2 to 3 feet, 02 deck astern was under water. A heavy Southwest swell sweeping vessel from bridge to stern, and Yokohama fenders washed up onto main deck. Spray was covering aft deckhouse. All mooring buoys intact; however, Yokohama fender previously tied to buoy missing. Position: 41°02.0'N, 69°27.5'W. Pollution consisted of thin brown layer 1/4-inch thick, extending 060°T, gradually breaking up into sheen. Conditions were unsuitable for boarding, except at bow and bridge (Figures 8 and 9).

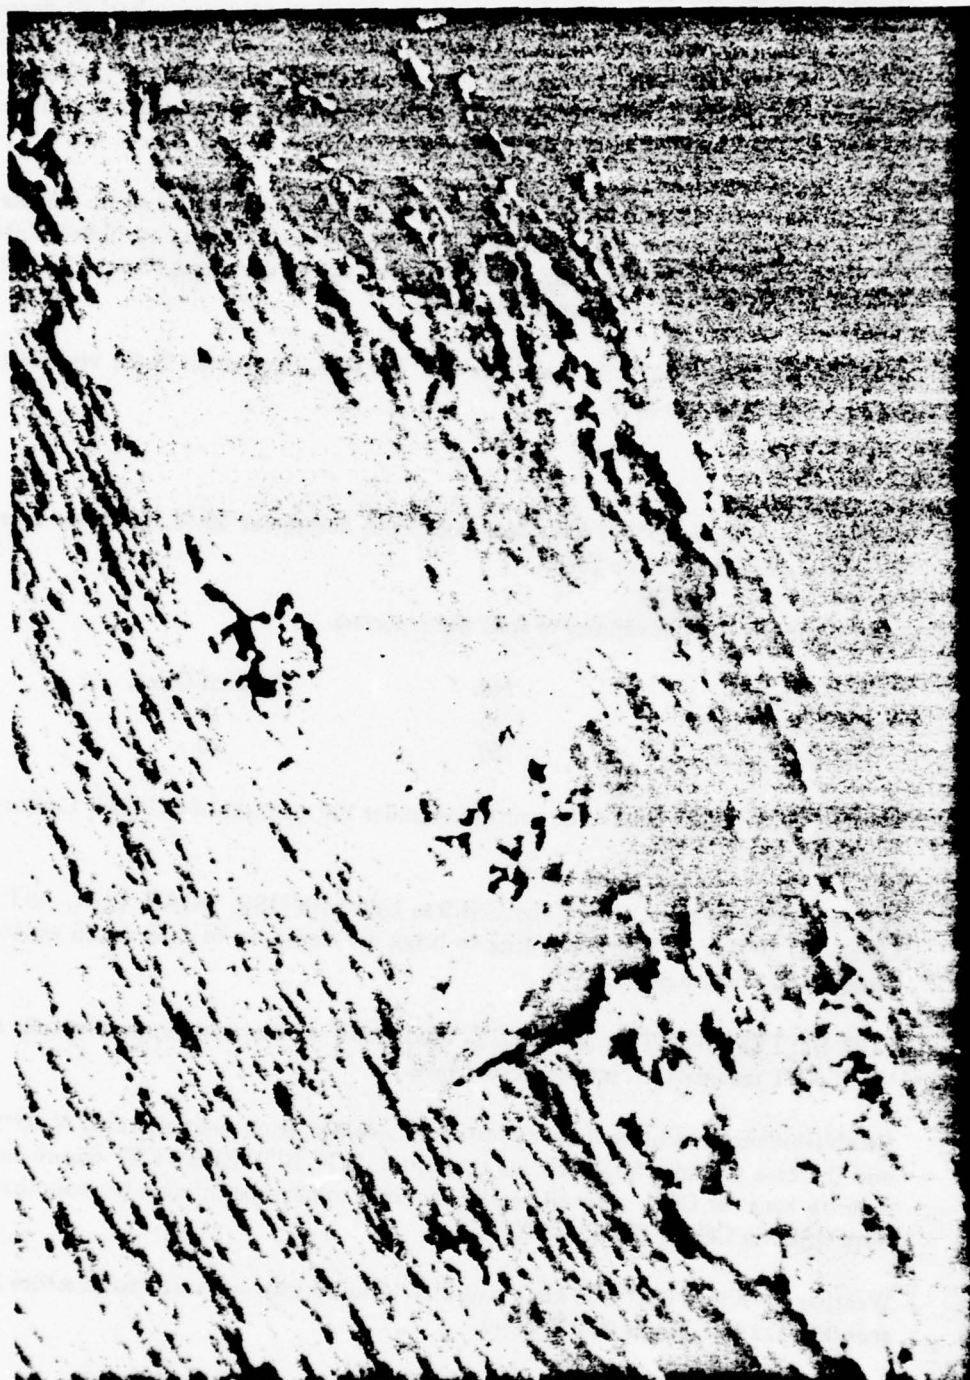
FIGURE 12 ARGO MERCHANT ON 27 DECEMBER 1976

- 2153 Vessel remained at position 40°02.2'N, 69°27.5'W. Stern section heading was 260°T with 5-degree list and sunk to 03 deck. Center section remained sunk, and bow section was working in the seas. Bow had laid over starboard to 40 degrees, keel 60 degrees above horizontal, and had rotated 90 degrees, and decks were facing Southeast vice Southwest. Waterline ran from 10 feet astern of forefoot to 35 feet aft of forecastle break on port side to 6 feet forward of forecastle break on starboard side. Occasionally bow section moved as much as 3 feet with seas.
